**DELAWARE RIVER BASIN  
LEAVITT BRANCH, BRODHEAD CREEK  
MONROE COUNTY  
PENNSYLVANIA  
NDS ID PA. 00814  
DER ID 45-250**

**SOIL CONSERVATION SERVICE DAM PA-463  
(LEAVITT BRANCH DAM)**

**PHASE I INSPECTION REPORT  
NATIONAL DAM INSPECTION PROGRAM**

**MARCH 1979**

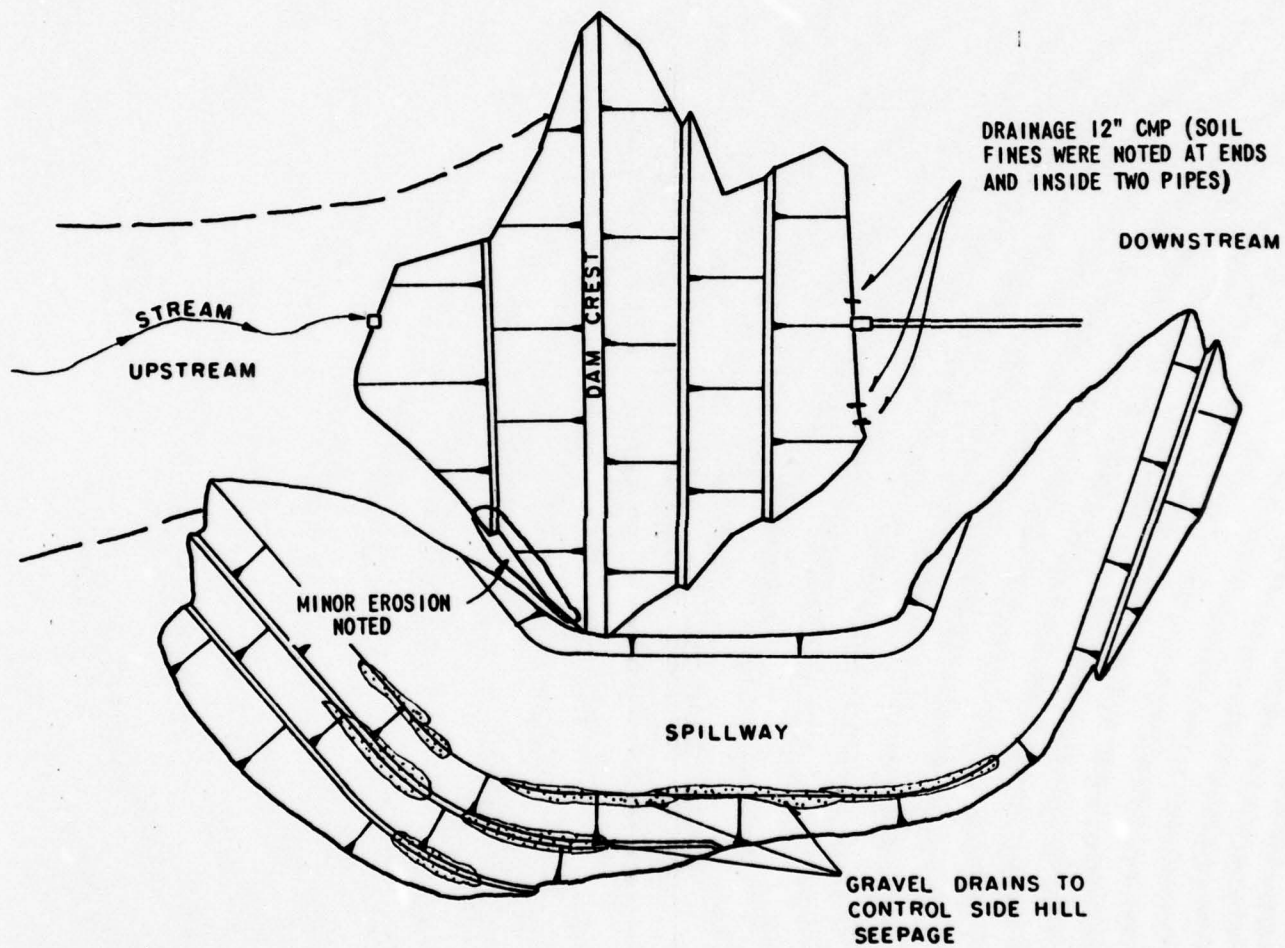
SEEPAGE LOCATION PLAN  
SHEET 5A OF 11

*None observed at base of dam but some (5-7 gpm) observed beneath 12" Dia. CMP at toe adjacent to right abutment. Two other 12" CMP were noted near the downstream toe but they were dry. Deposits of fine sand were noted at the ends of all these pipes. It appears that some minor piping has occurred. It is also possible that this sand is associated with the stabilization of the drainage rock around the pipe. Regardless of the cause, the source of the fine-sand should be investigated.*

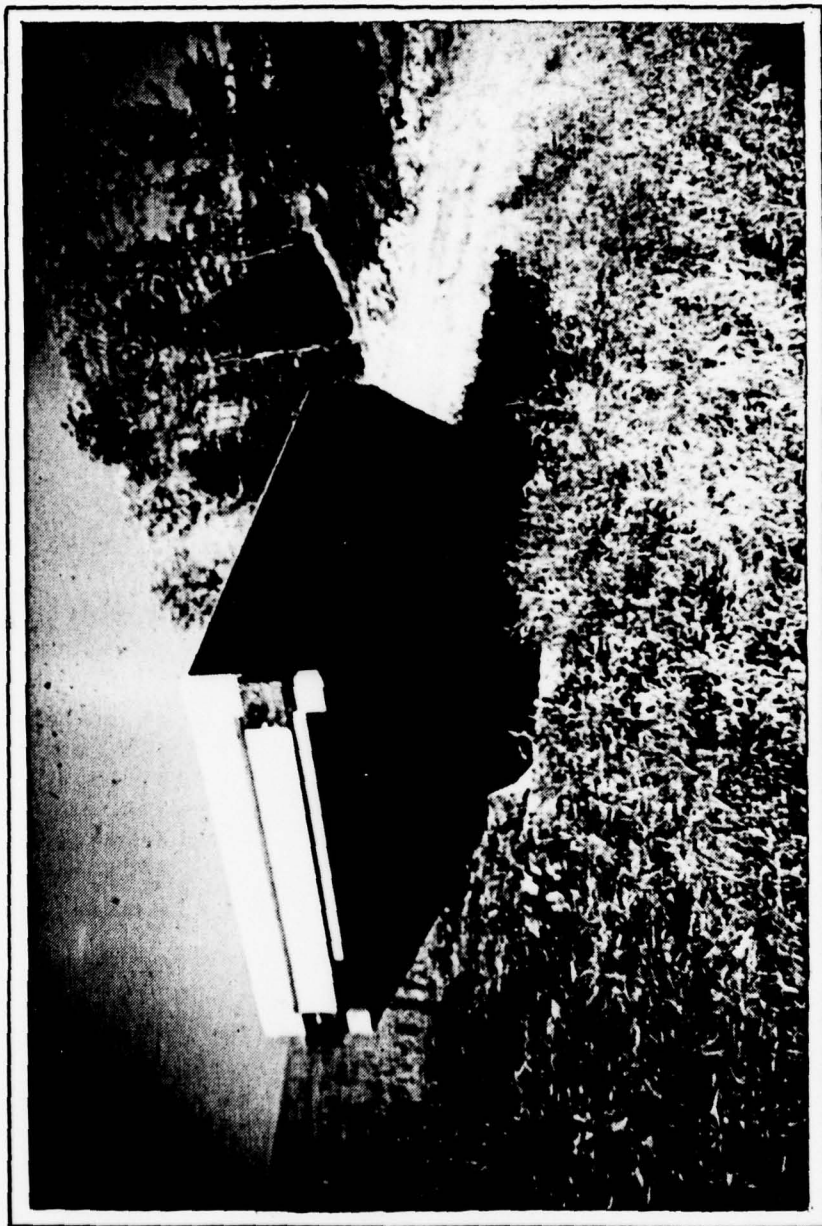
1. Principal Spillway. Exposed portions of the riser and reservoir drain inlet were inspected and observed to be in good condition with no signs of distress, concrete spalling, or other indications of poor construction or movement of the riser. The reservoir drain inlet was partially clogged with a log, resulting in the backup of approximately 8 inches of water. The impact basin located at the downstream toe was also inspected with no signs of deterioration. In general, the outlet system appears to be in good condition.

VIEW OF INTAKE RISER ON UPSTREAM SLOPE.

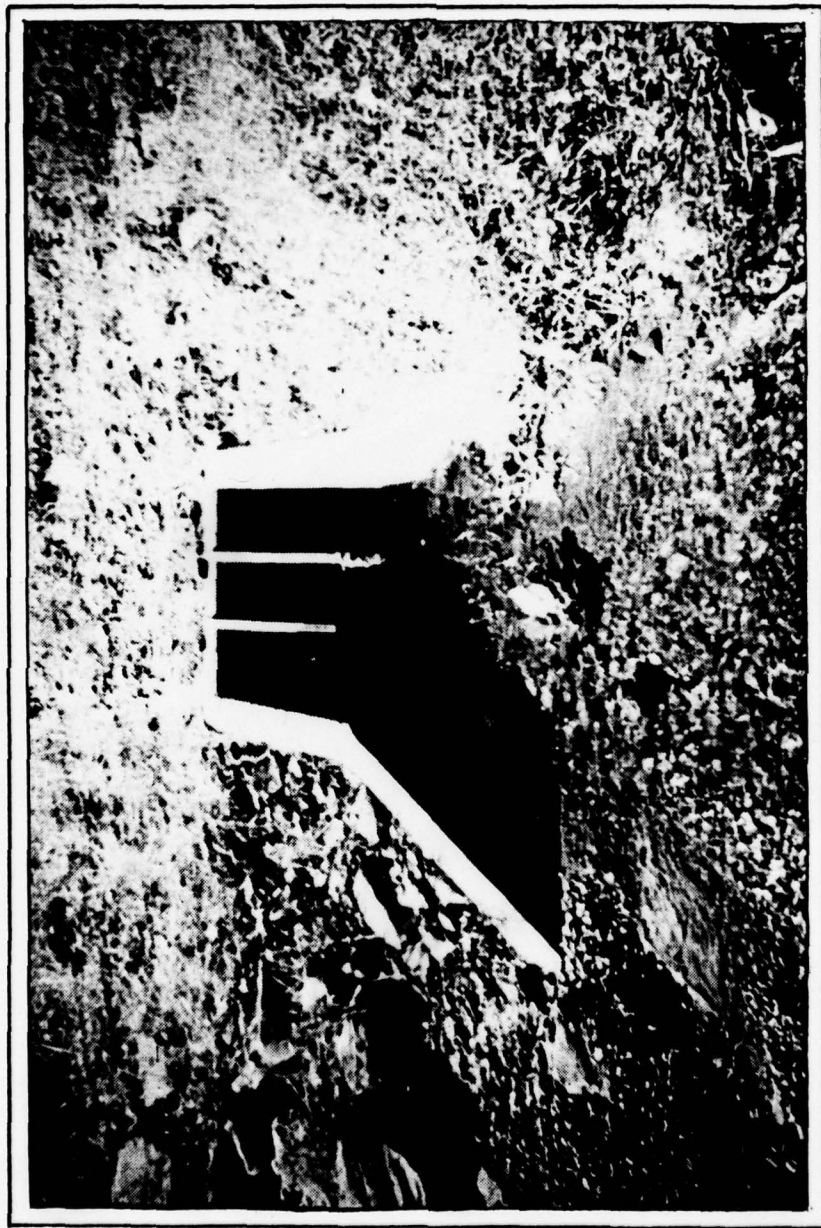
PHOTOGRAPH NO. 2

VIEW OF POND DRAIN INTAKE.

1. It is recommended that the trash racks be monitored and kept thoroughly clean to prevent clogging similar to what has happened during the winter of 1977-78.
2. The log currently wedged at the base of the entrance tower should be removed to improve flow through the drain.

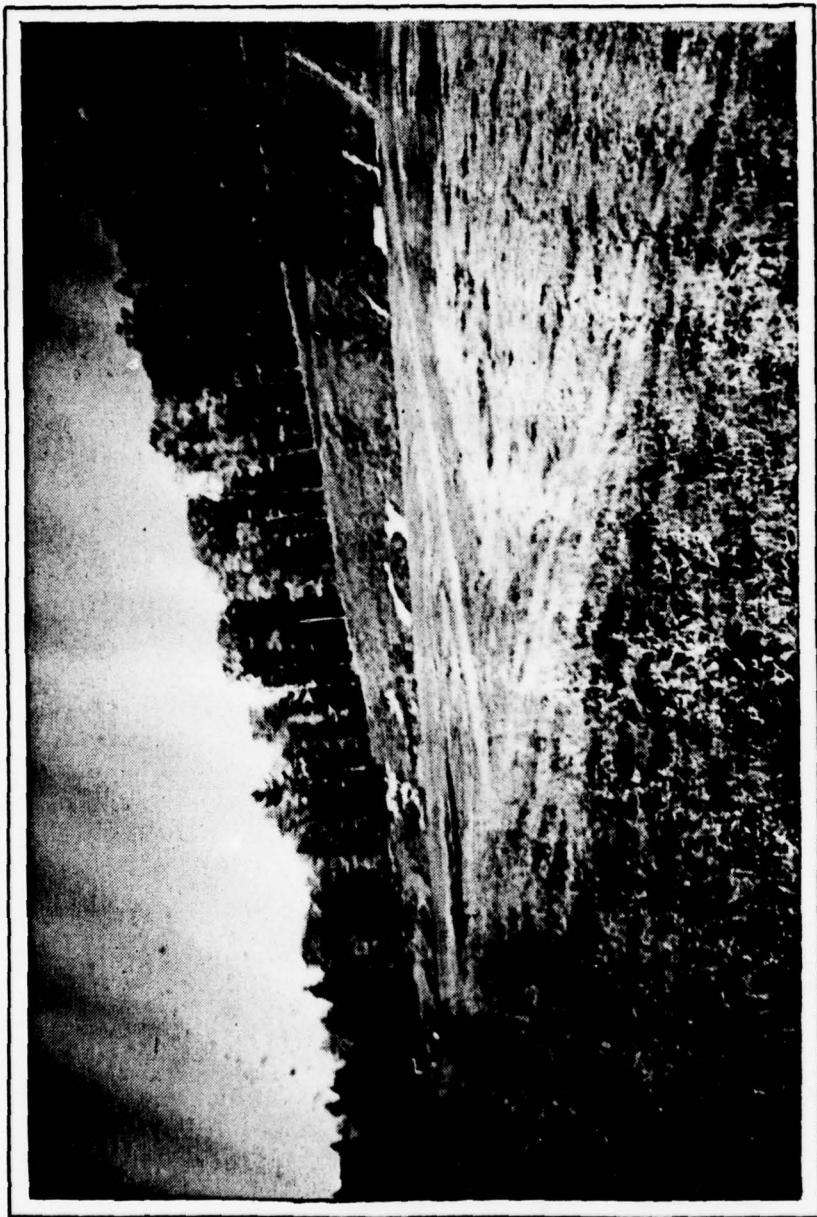
2. Emergency Spillway. The emergency spillway was found to be in good condition, being excavated into erosion resistant materials and grass-lined. There are no signs of significant erosion, channel deterioration or other evidence that the spillway would not function as designed. As noted on design drawings, the benches on the right side cut of the emergency spillway channel contain gravel-filled drainage trenches to control sidehill seepage. Additional drains were installed at the junction of the channel bottom and right wall and in the right channel wall (see Photo 4). These systems were carefully inspected and assessed to be operating properly.

APPROACH CHANNEL	Grass channel observed to be in good condition. At the right edge of the channel along the channel bottom, a drainage trench was excavated and filled with gravel to control side hill seepage. The drainage system appears to be functioning properly.	
------------------	---	--

EMERGENCY SPILLWAY LOOKING DOWNSTREAM.  
NOTE THE SEEPAGE DRAINS IN THE SLOPES  
OF THE RIGHT ABUTMENT.

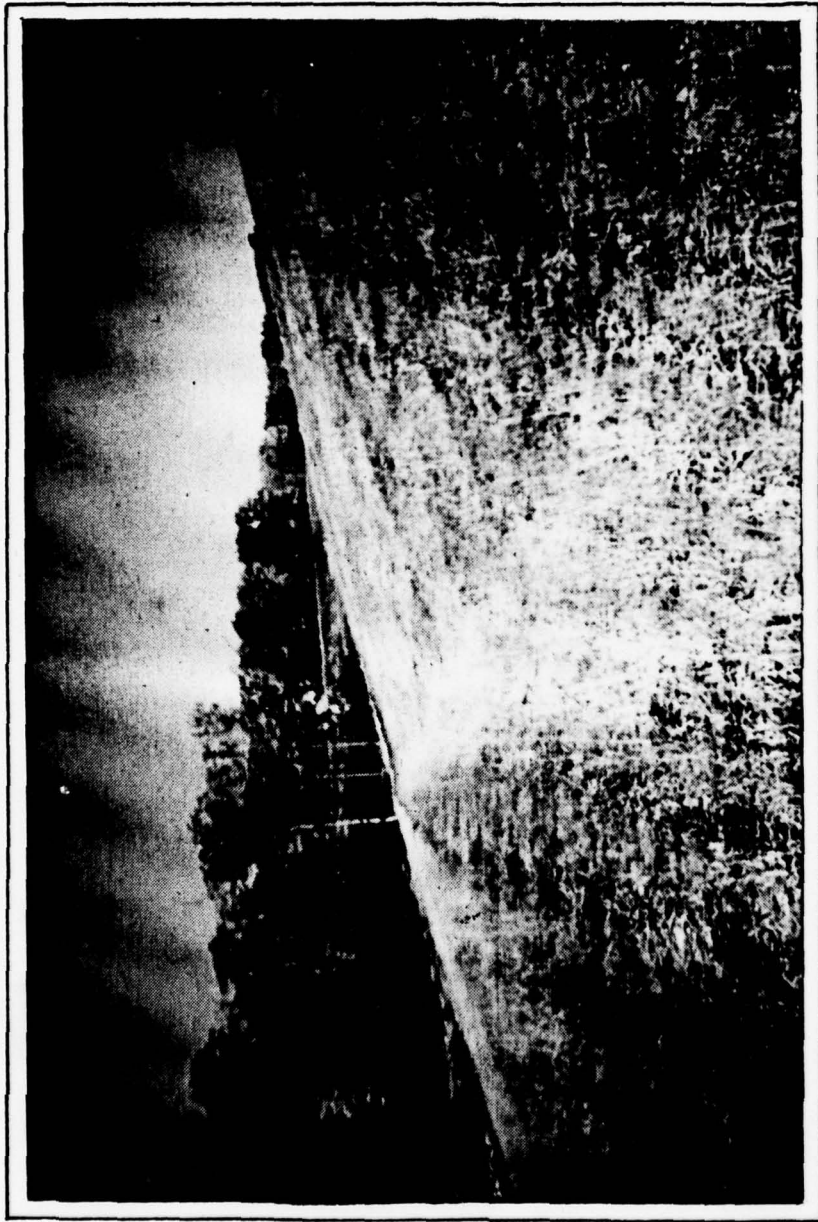
PHOTOGRAPH NO. 5

Both the upstream and downstream slopes of the embankment are covered with Crownvetch and other vegetation. There is no evidence of unusual movement, distortions or deterioration observed between the junction of the embankment and the abutment and between the spillway and the dam.

OVERVIEW OF DOWNSTREAM SLOPE LOOKING  
TOWARDS THE RIGHT ABUTMENT.

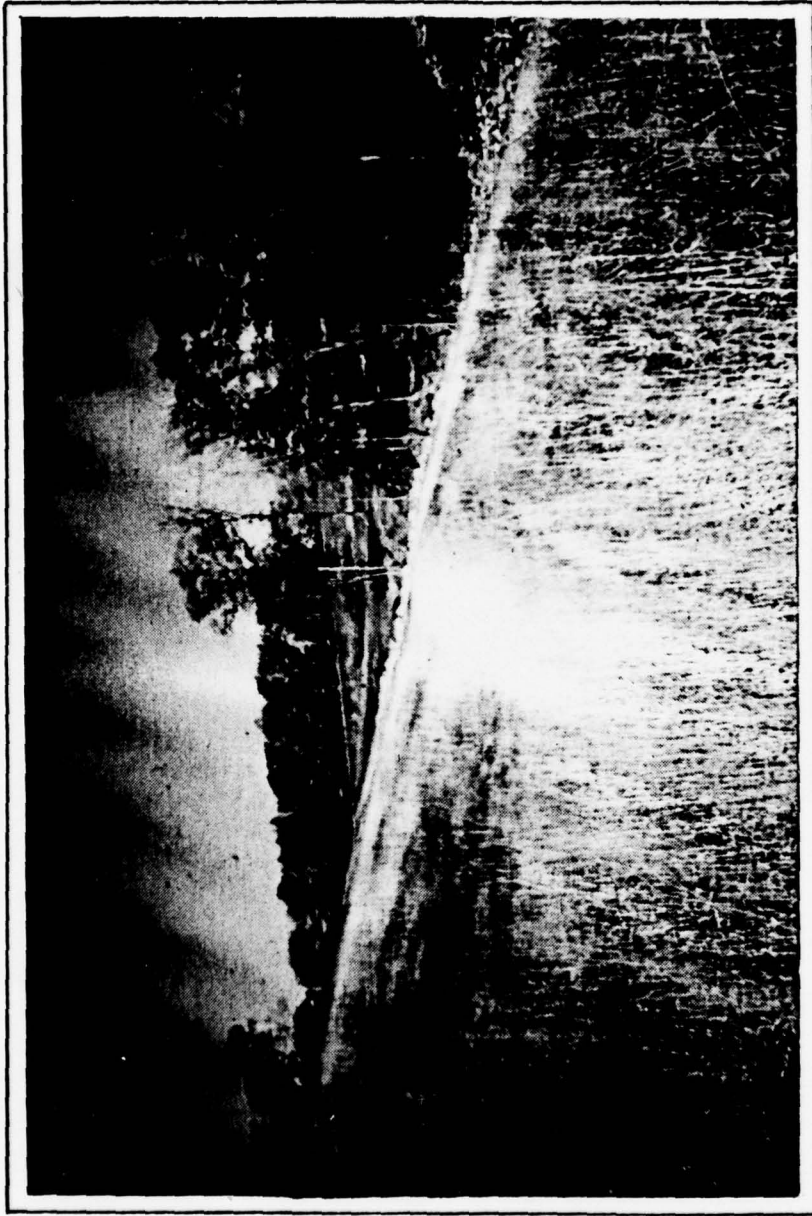
PHOTOGRAPH NO. 6

b. Dam. Careful inspection of the embankment revealed no signs of surface cracks, unusual movements or cracking at or beyond the toe. Some minor erosion and two depressions were observed on the upstream side of the dam just below the first bench. These benches are graded towards the embankment but do not drain laterally. As a result, there is standing water on the benches. No unusual distortions were observed relative to the vertical and horizontal alignment of the crest when checked with survey equipment.

OVERVIEW OF UPSTREAM SLOPE LOOKING  
TOWARDS THE RIGHT ABUTMENT.

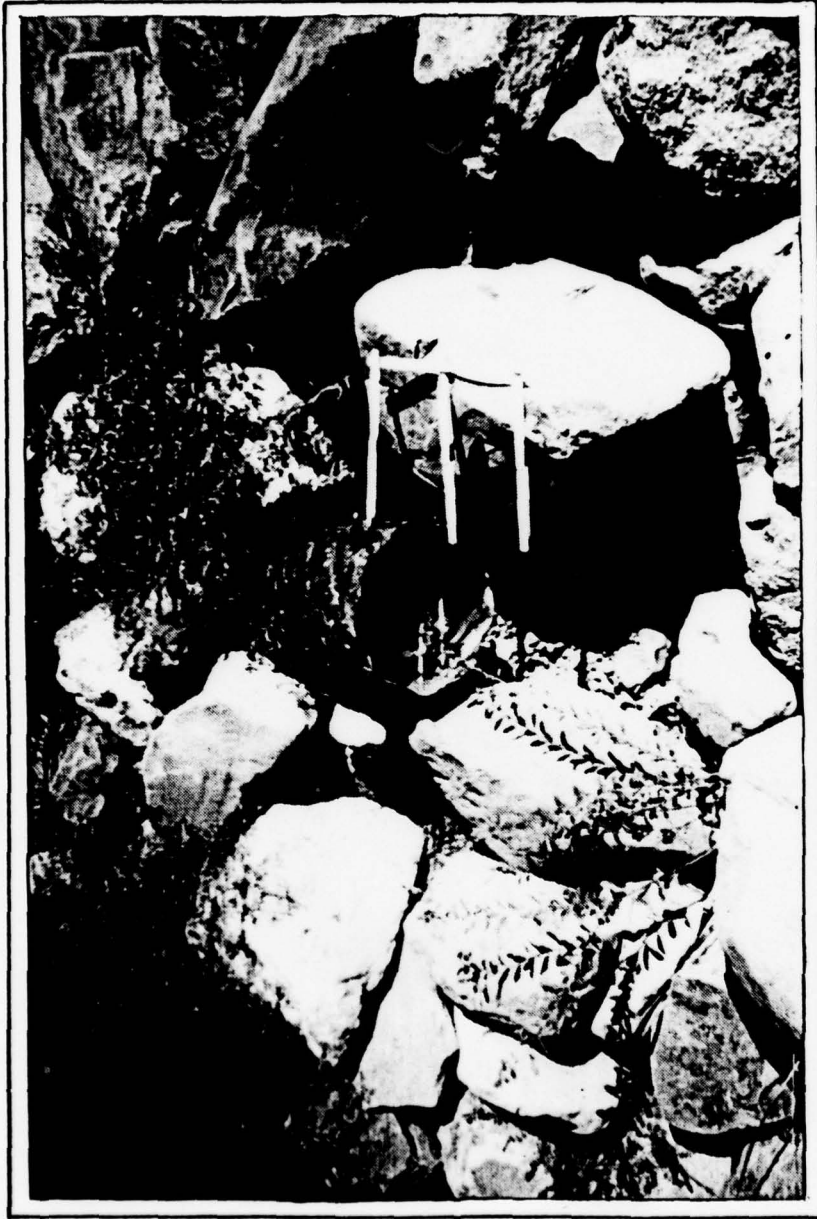
PHOTOGRAPH NO. 8

EMBANKMENT DRAIN THROUGH ROCK TOE.
